## **Technical Report ARWSB-TR-11017**

# **Development of an Accelerated Hydrogen Embrittlement Test for Manganese Phosphated Steels**

**G.N. Vigilante**

**ARMAMENT RESEARCH, DEVELOPMENT AND ENGINEERING CENTER**  
Weapons & Software Engineering Center  
Benét Laboratories

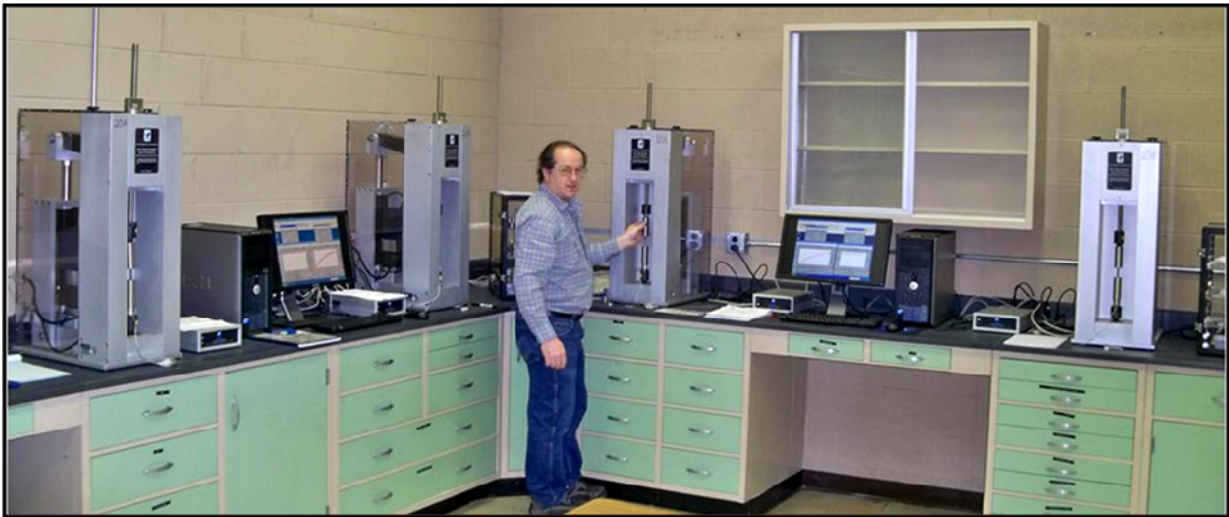
**Figure 3.** ISL testers at US Army, Benét Laboratories.

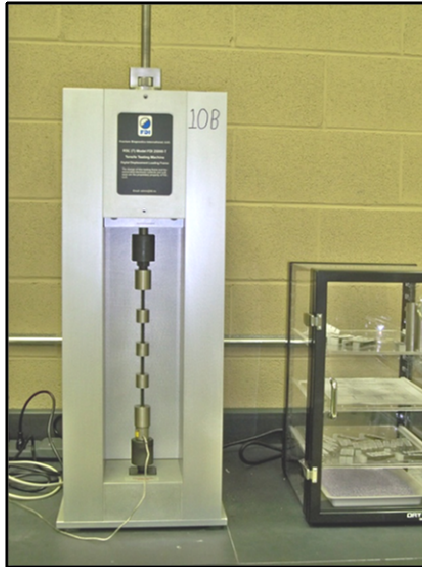
**Figure 12.** Four notched tensile specimens ganged together.

Some of these ganged tests raised the issue of potential bending in the load train which could bias the results (results in premature failure). Consequently, flat-sided tensile specimens were strain gauged in order to determine if ganging specimens resulted in additional bending. Test results indicated bending of approximately 3-16% regardless if testing was performed on a single specimen or four (4) specimens ganged together. Additionally, testing between different ISL machines demonstrated similar results. The amount of bending that was observed is similar to what has been reported in the appendix of ASTM E1012 “Standard Practice for Verification of Test Frame and Specimen Alignment Under Tensile and Compressive Axial Force Application”. Note that if any bending were to influence a test result, it would be a conservative test since the specimen would fail at a lower NFS.
